# Sand Deposit Control Strategy on Centrifugal Pump Type Overhung 4 Size 4x11 Using API 682 Piping Plan 13

Miftahul Fahrizal Nur Malik, Noor Hidayati\*, and Dianta Mustofa Kamal

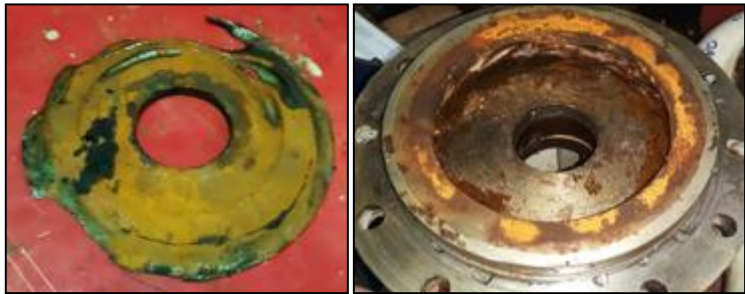
Figure 2. Damage that occurs to the pedestal cover and pedestal (Documentation PT. XYZ)

It is seen from **Table 5** that the Pedestal Cover and Pedestal had previously suffered damage due to erosion and corrosion on their surfaces, and after improvement, the pedestal cover and pedestals were only subjected to surface corrosion due to exposure to seawater fluids during the maintenance of the tank separator. This corrosion and erosion might occur in the pump due to suspended solids in the fluid (LEE & LIM, 2009). The image of damage prior to improvement indicates that the pedestal cover suffers from erosion damage, so it cannot be repaired and must be re-fabricated. Meanwhile, Pedestals require significant repairs because the dimensions wasted by erosion must be replenished using welding and machining methods.

After improvement, the cost of repairs can be reduced as the Pedestal Cover can still be repaired with the sandblasting and coating methods. Sandblasting is a common method to clean corrosion on a metal surface (Ding & Poursaee, 2017), while Pedestals can also be fixed with the sandblasting method. Below is a table of improvement costs before improvement can be seen in **Table 6**.
